CONTRIBUTION TO THE CONCRETE STRUCTURE PROJECT EXECUTED WITH ROLLED PEBBLES IN THE CITY OF MANAUS - USUAL PROCEDURES AND RECOMMENDED STANDARDS

ORIGINAL ARTICLE

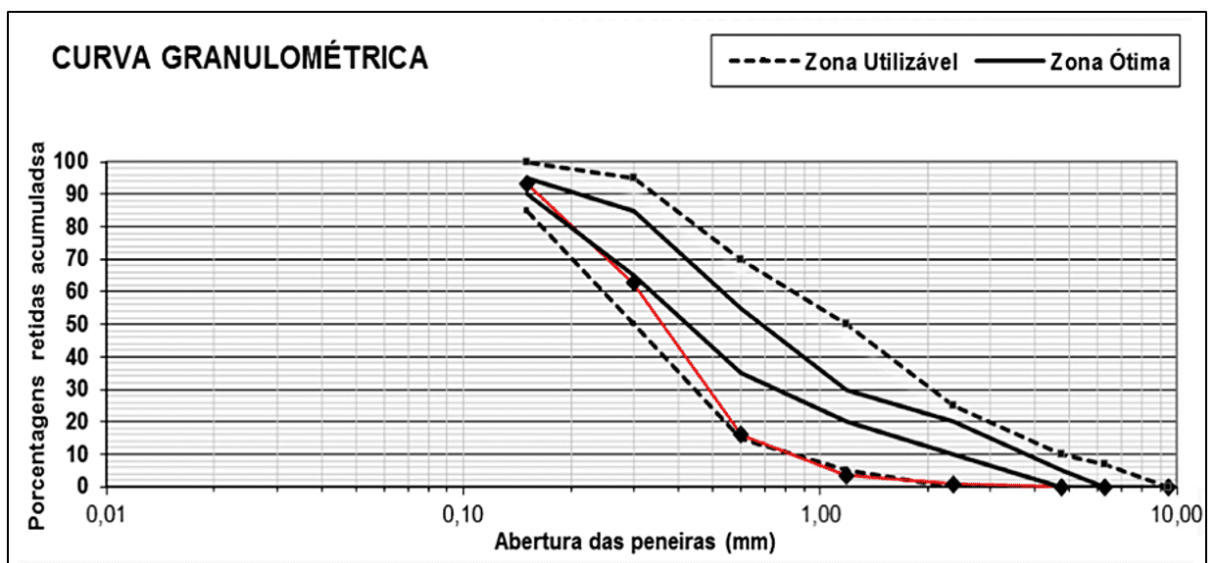
NBR 7211 (ABNT, 2022) prescribes limits for the particle size distribution, defining working particle size distribution ranges as shown in Figure 1 for fine aggregate: the usable zone (defined by dotted lines) and the optimal zone (defined by solid lines). The particle size distribution curve, represented by red line segments, illustrates, for example, the low quality index of sand collected in the *Japiim* district in the South zone of the city of Manaus.

Figure 1: Particle size distribution of sand collected in the *Japiim* district

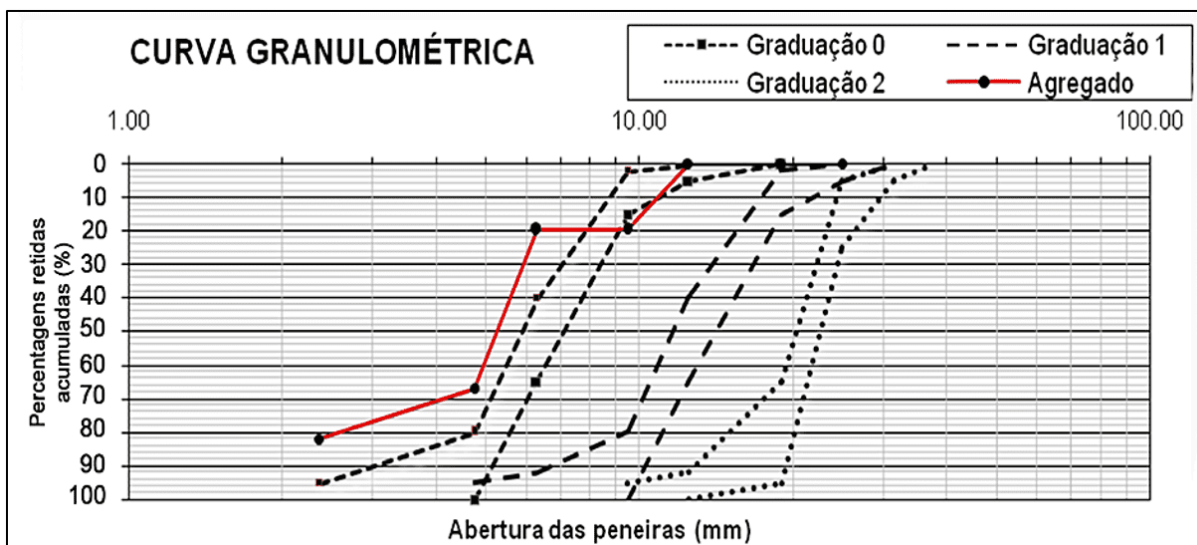
According to NBR 7211 (ABNT, 2022), the limits of the granulometric composition of the coarse aggregate are defined by the relationship d/D (smaller (d) and larger (D) dimensions of the coarse aggregate): $d(\text{mm})/D(\text{mm}) = 4.75/12.5$; $9.5/25$; and $19/31.5$, respectively, referred to as gradations 0, 1, and 2. The granulometric curve formed by red line segments, obtained from a sample collected in the *Novo Israel* neighborhood, North zone, shows a low quality index of the rounded pebble regarding its granulometric distribution.

Figure 2 - Granulometry of the rounded pebble collected in the *Novo Israel* neighborhood

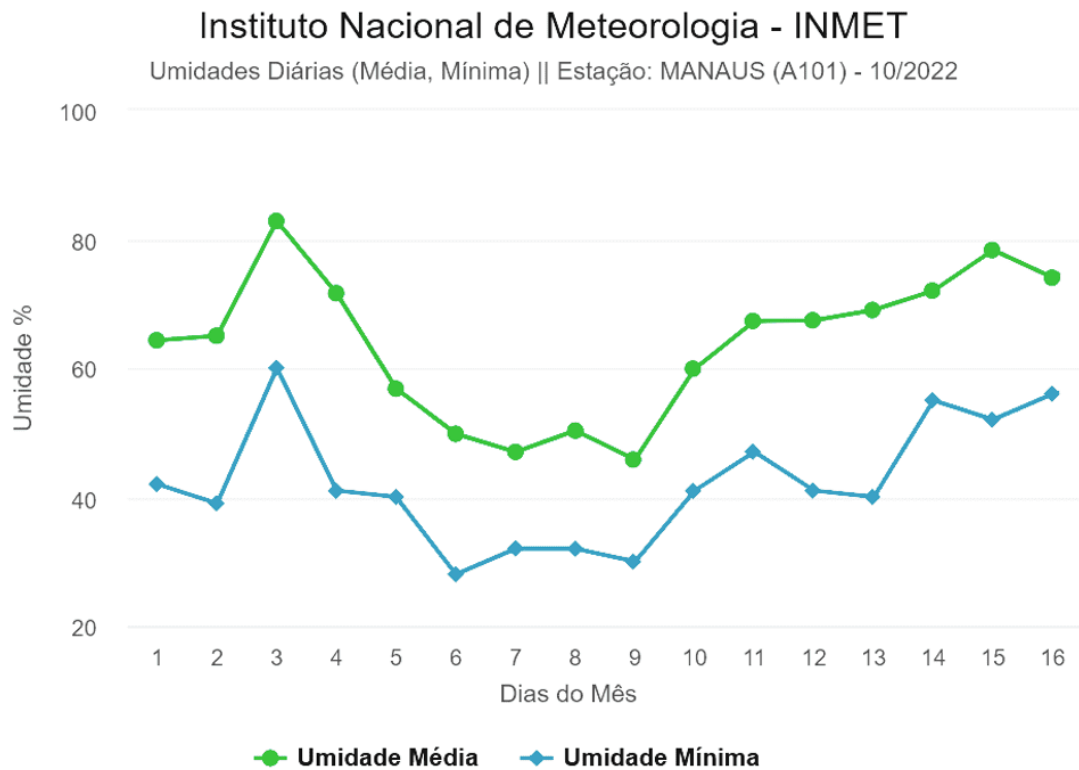
In the city of Manaus, according to the National Institute of Meteorology (INMET), the air humidity remains around 80% for most of the year. However, from July to early November, environmental humidity rates decrease significantly, sometimes dropping below 30% on certain days. This is illustrated in the graph shown in Figure 4 for the first few days of October 2022.

Figure 4: Variation of relative air humidity in the early days of October 2022

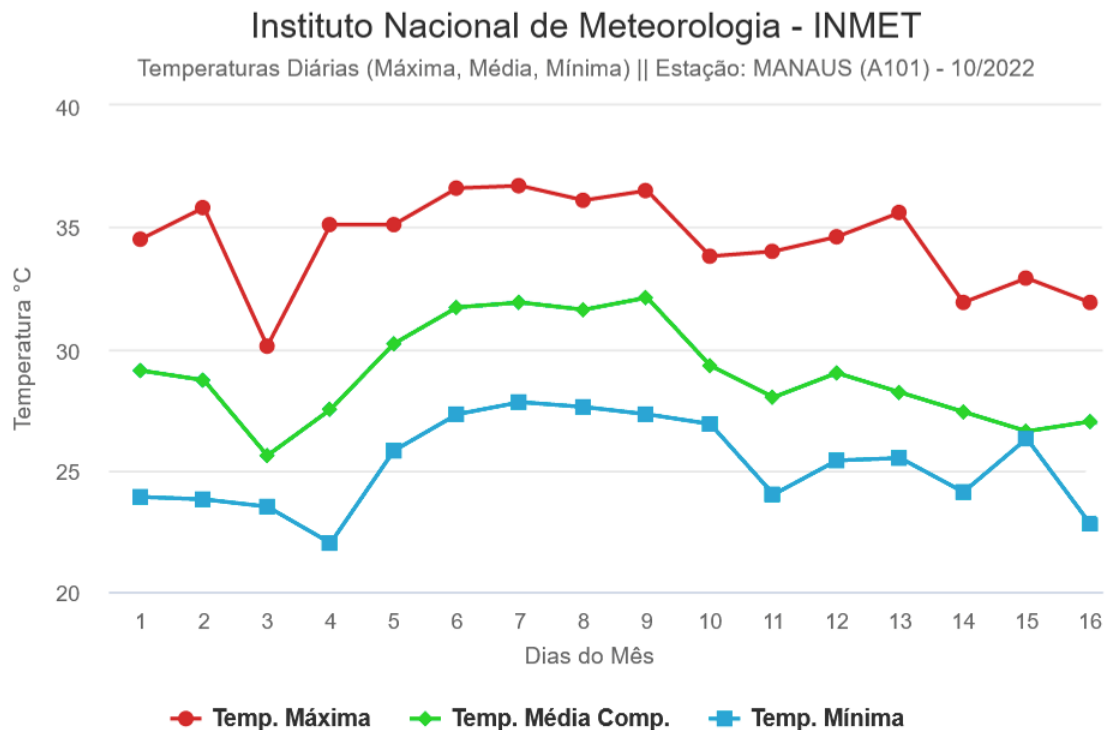
During this period, the maximum temperatures are close to 40°C, as shown, for example, in the graph in Figure 5 for the first few days of October 2022. Combined with the low daily humidity rates and high temperatures, from July to November, there are water drawdowns in the *Negro* and *Solimões* rivers and also a lack of rainfall in the region.

Figure 5: Temperature variation in the first few days of October 2022

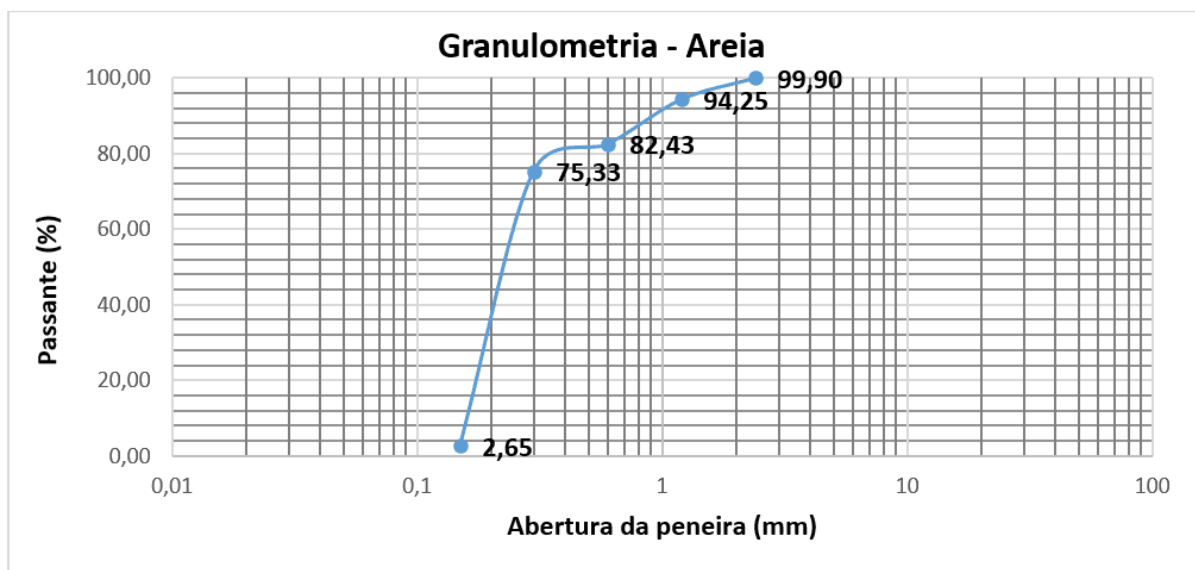
In the North zone, for example, the sand and rolled pebble presented the particle size distribution curves shown in Figures 6 and 7, and the following results for:

1. a) sand: unit and specific mass in g/cm^3 , respectively, 1.70 and 2.60; fineness modulus = 1.45; classification = very fine sand;
2. b) rolled gravel: loose and compacted unit masses, and specific mass in g/cm^3 , respectively, 1.64, 1.67, and 2.63; maximum diameter = 9.5mm.

Figure 6: Particle Size Distribution of Sand Collected in the Northern Zone

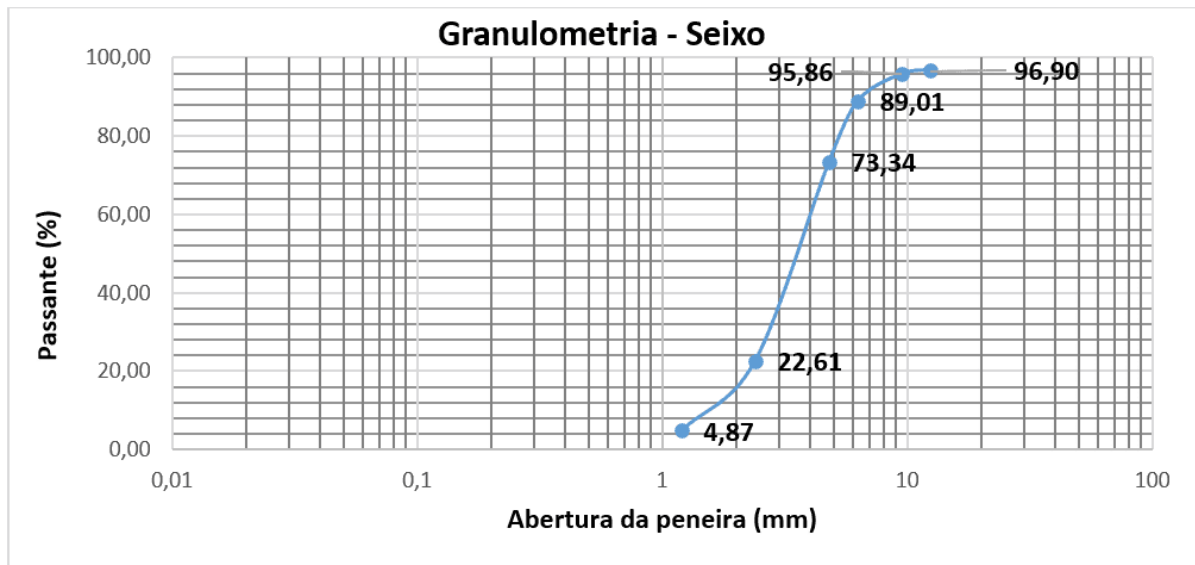
Figure 7: Grain size distribution of the collected gravel in the North zone

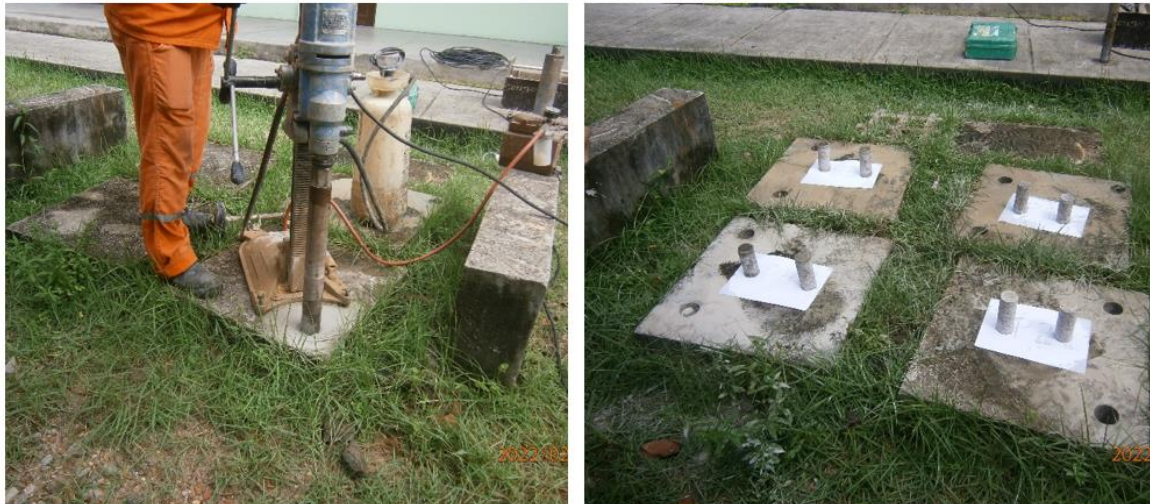
The procedure for extracting the test specimens followed the recommendations of NBR 7680-1 (ABNT, 2015) and was carried out by a specialized company in civil construction material testing. Figure 8a shows the equipment used for extracting the specimens, the DK 12 TIROLIT, and the test specimens extracted from the slab elements, as shown in Figure 8b.

Figure 8: Extraction of test specimens: a) Extraction equipment (left figure); b) Test specimens extracted from slabs (right figure)

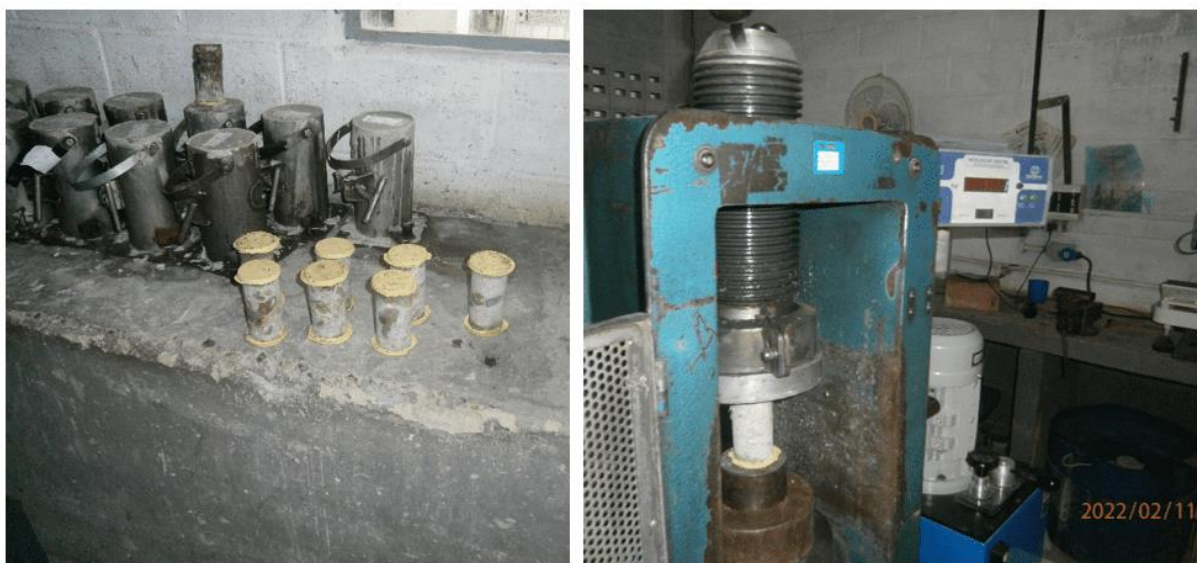
The cylindrical specimens were capped with sulfur, as shown in Figure 9a, to ensure uniform stresses across the cross-sections. The tests were conducted using a hydraulic electric press, Pavitest brand, model I-3001-B/No. 984, as depicted in Figure 9b.

Figure 9: Testing procedures: a) Specimens capped with sulfur (left figure); b) Testing equipment (right figure)

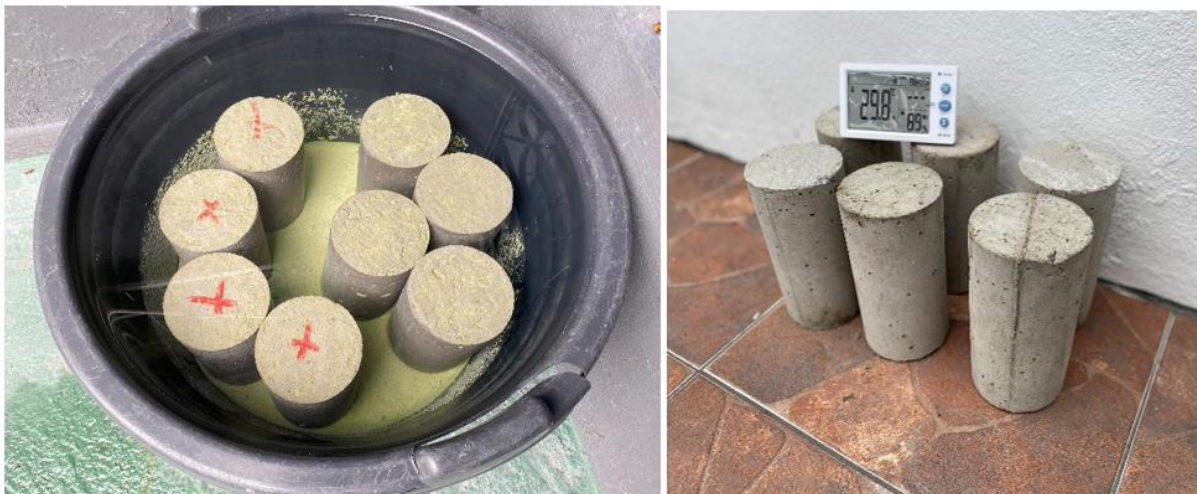
After this phase of the research, cylindrical specimens were molded using metal molds of 10cm x 20cm and 15cm x 30cm, and axial compression tests were conducted as recommended by NBR 5738 (ABNT, 2016), which deals with concrete - procedure for molding and curing specimens. With the aim of verifying the quality and uniformity of the concrete used in the work, after removing the forms, the cylindrical specimens were subjected to curing processes. The strength gains of concretes with rolled gravel in their composition were evaluated in the following situations: immersion of the specimens in a saturated solution of calcium hydroxide, as prescribed by NBR 5738 (ABNT, 2016), as shown in Figure 10a; cycles of wetting the surfaces of the concrete elements at the beginning and end of the day, as is the usual procedure in the city of Manaus; and natural curing of the concrete in the open air. In all these situations, measurements of relative humidity and temperature were taken with a digital thermo-hygrometer model MT-241A, as shown, for example, in Figure 10b.

Figure 10: Curing Procedures and Humidity and Temperature Measurement: a) Specimens immersed in the solution (left figure); b) Specimens exposed to the open air (right figure)

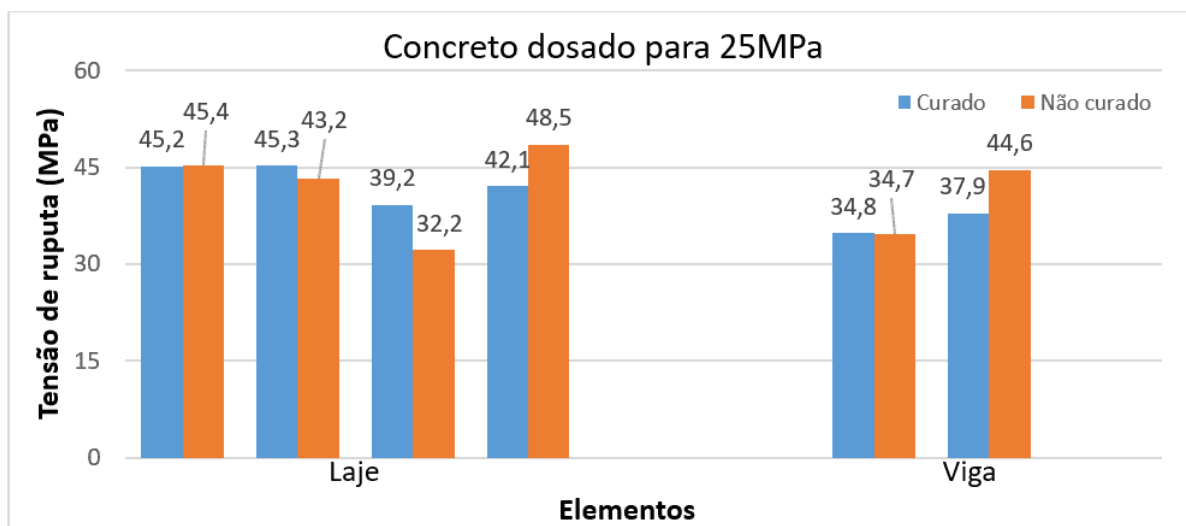
The initial results were obtained from concrete structures, representing a beam and a slab, exposed to outdoor conditions for approximately seven months. During the exposure period of the concrete elements to outdoor conditions, including sun, rain, and wind, two slab elements and one beam element were subjected to the usual curing process in Manaus, which involves cycles of wetting at the beginning and end of the day. The results from axial compression tests are presented in Figure 11, obtained from elements cured by the customary regional process and from specimens without artificial curing. The tests were conducted in February 2022, and the results were randomly selected in pairs for the graph.

Figure 11: Compression strength of cured and uncured concretes

These results show that the strengths of the concretes made with rounded gravel in both situations, exposed to the open air, with and without curing, are practically equal. During the strength gain period of these elements, which encompassed the months from November to February, the relative humidity was around 80%, with a predominance of daily rainfall in the region.

The average stresses in the slabs were 42.9 MPa for elements cured by the wetting process and 42.3 MPa for elements exposed to the open air. In the case of the beam elements, the analysis of reliable values also indicated a small discrepancy in the average stress, namely 36.3 MPa and 34.7 MPa, respectively. It is worth noting that the slab elements have a smaller thickness than the beam elements and are more sensitive to natural factors such as rain, temperature, humidity in the air, and in the soil.

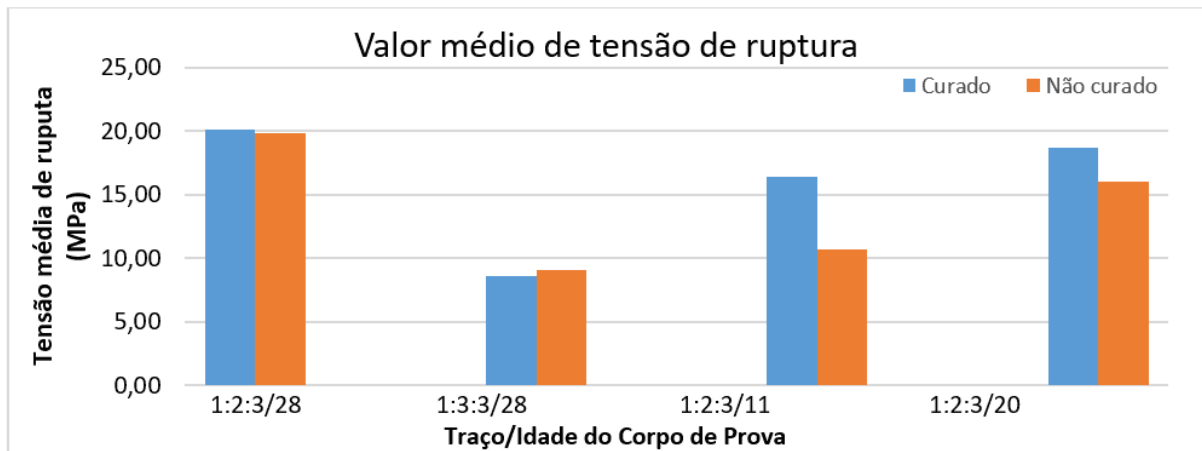
The results shown in tables 3, 4, and 5, presented in the graph in Figure 12, related to tests conducted in the months of February, March, and April 2022, during the rainy season with humidity around 80%, revealed that differences in compression strengths between the two situations begin to emerge.

Figure 12: Average compressive strength of cured and uncured specimens
